Growth of Brick in Freezing Climates

By Arthur H. MacLeod, P.E.

Abstract

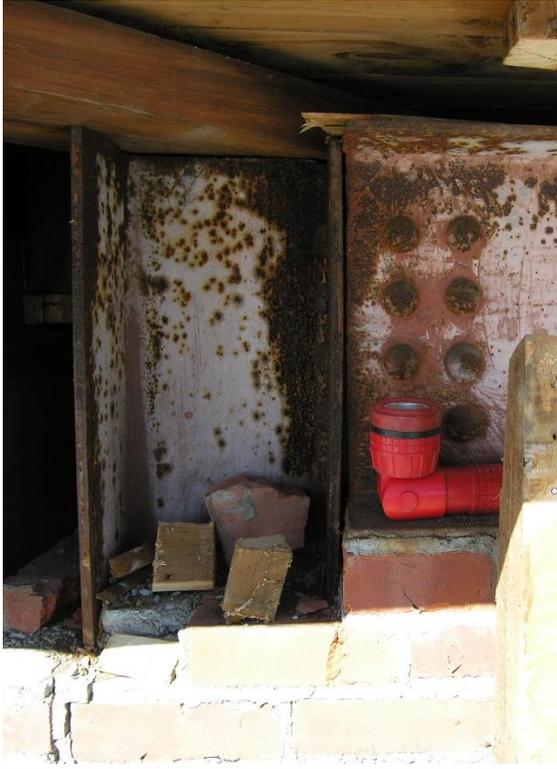
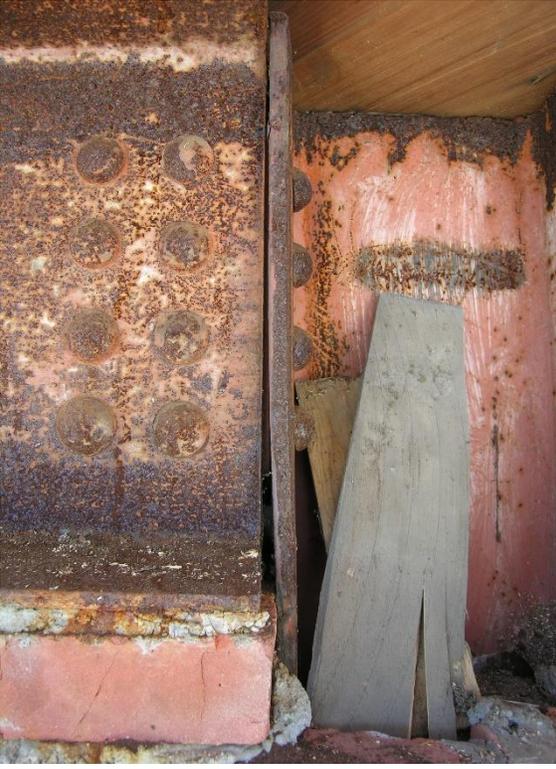
In 2006 demolition started on a 20-foot square steel framed tower with common brick infilling the steel frame and face brick enclosing the frame. Before demolition, cracks were present in the corners of the tower. After face brick was removed at a spandrel beam level, I could see that brick had pushed against the steel columns dislocating the column flanges by one-quarter inch at each corner. The columns are spaced 18 feet center to center. The one quarter in deformation is from brick growing over nine feet. This figures to 0.0023 inches per inch. This figures to 11.5 times Palmers testing and 3.89 times the maximum figure tested by Davison. It is 11.5 times the amount recommended by the BIA in their TN 18A.

<p>Backup brick pushing against column under spandrel beam at southwest corner. Column flange dislocation is ¼ inches.</p>	<p>Backup brick pushing against column under spandrel beam at southeast corner. Column flange dislocation is ¼ inches.</p>

The best defense of preventing damage from brick expansion due to freeze growth is to allow building heat to be lost through exterior walls. When existing buildings that show evidence of cracking even though uninsulated, the author recommends maintaining a 70 -degree indoor temperature when forecasts call for temperatures below 20°F . Although the critical freezing temperature appears to be 14°F , use 20°F to guard against error.

Where renovation programs call for improving energy efficiency, consider adding additional insulation on roofs and non-brick areas of the building envelope along with better thermally performing windows. If wall insulation is still desired, test backup brick and examine its degree of firing. Hard burned backup will lower the risk. Still, use as little insulation to meet energy goals on brick walls knowing that saturated backup brick will risk expansion at 14°F .
